Subject:- Final Accident Report of N350JF Learjet 35A

**AIRCRAFT ACCIDENT
INVESTIGATION REPORT
N350JF, LEAR JET 35A ACCIDENT ON THE
29TH OF AUGUST 1999 IN ETHIOPIA**

**Ethiopian Civil Aviation Authority
Flight Safety Department
P.O.BOX 978
Addis Ababa – Ethiopia
April, 2001**

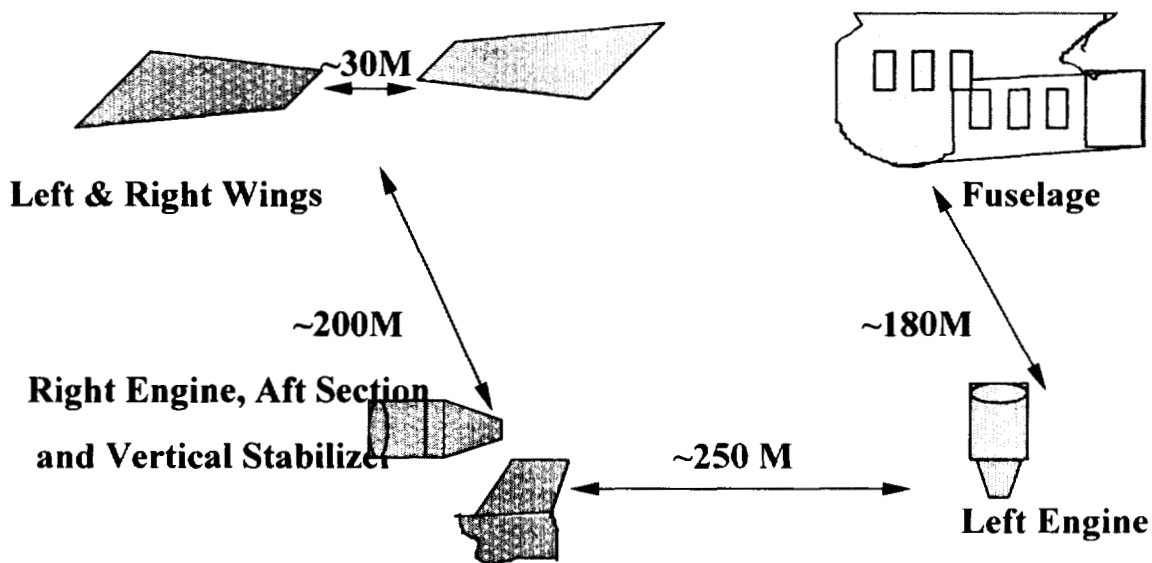
Figure 1

The general distribution of the wreckage looked somewhat similar to the wreckage chart shown in figure 1. Both wings were found separated and resting on a hill 30 meters

apart. The wing tip fuel tanks were missing from both wings. The right engine and the vertical stabilizer lay some 200 meters on the slopping side of another hill away from the wings. This engine was found detached, but intact. It showed severe fire burn and heavy impact damage. While some portion of the aft section was still on the vertical stabilizer, the horizontal stabilizer was missing and was not located anywhere in the area. The left engine was found some 250 meters from the other engine; it was severely damaged by impact. This engine was also found intact. There was no any trace of fire on this engine. The whole fuselage was found shattered and confined in a dry riverbed about 180 meters from the left engine. The whole wreckage came to rest in general over an area of radius 300 meters.

The aircraft disintegrated in air and fell in pieces over unpopulated rugged country. The wings, engines and the fuselage were found scattered over an area of radius 300 meters.

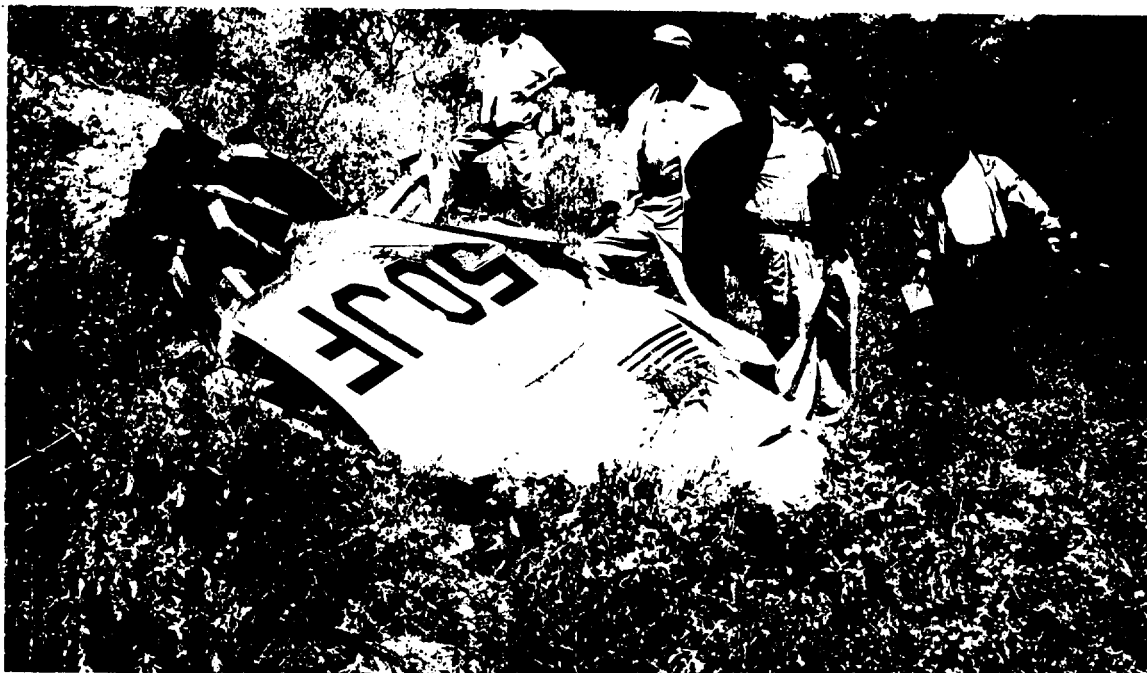
VERTICAL STABLIZER

The right engine sustained severe fire burn. The aft section, which came off with the vertical stabilizer, showed also some indication of fire attack.

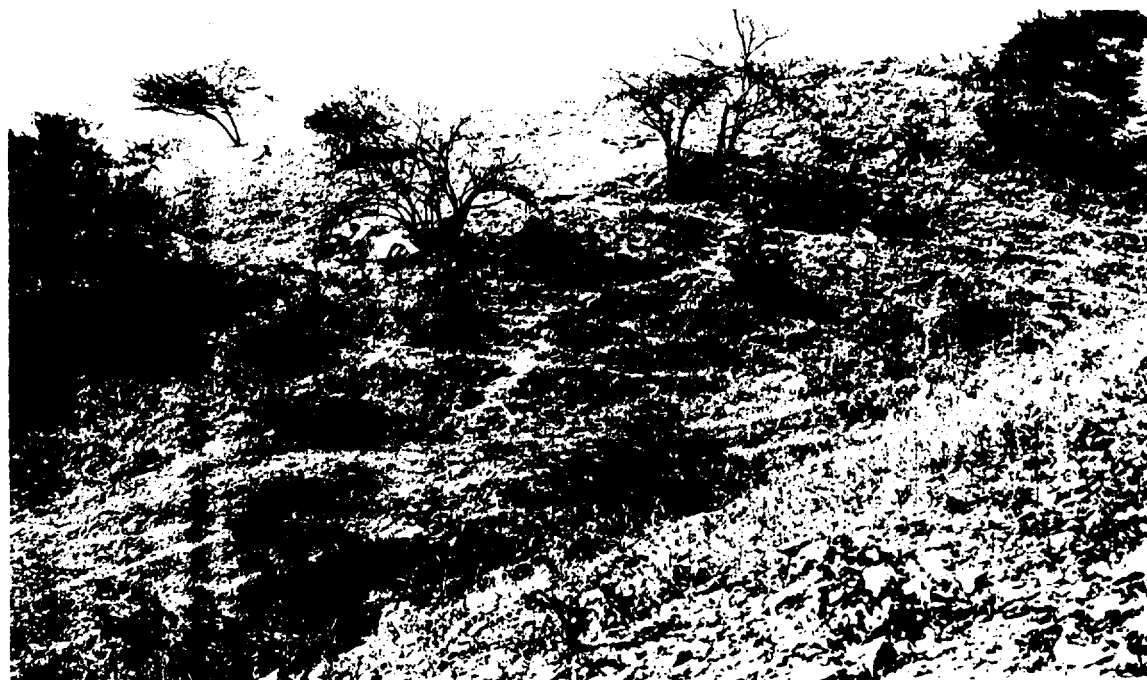
RIGHT ENGINE RESTING ON THE SLOPING SIDE OF A HILL

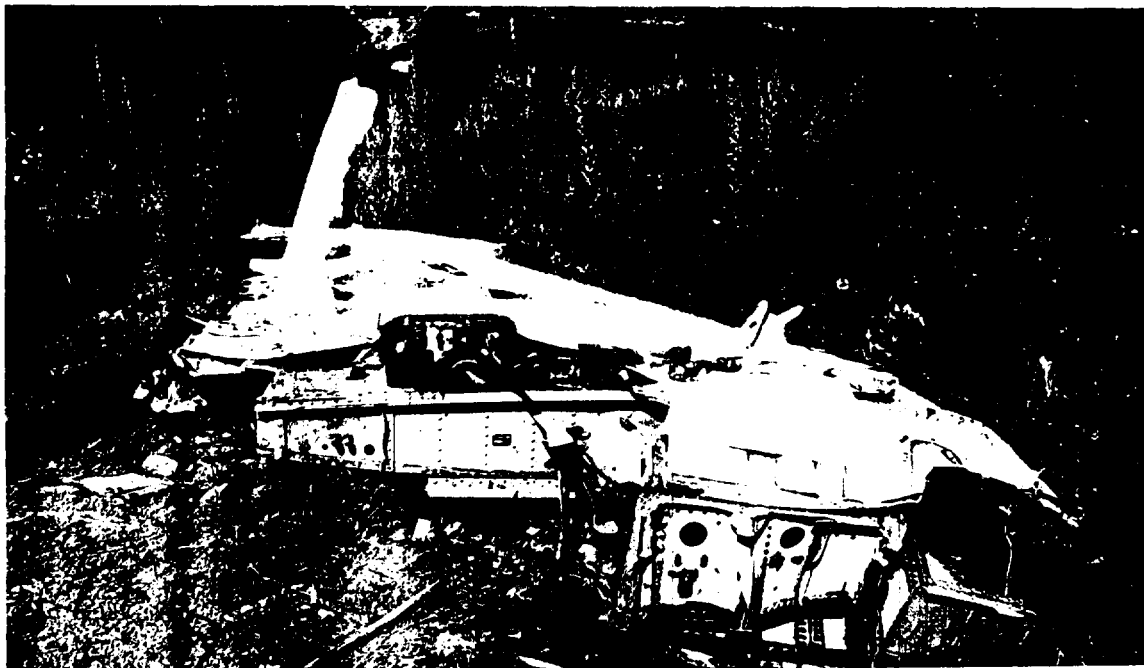
RIGHT WING

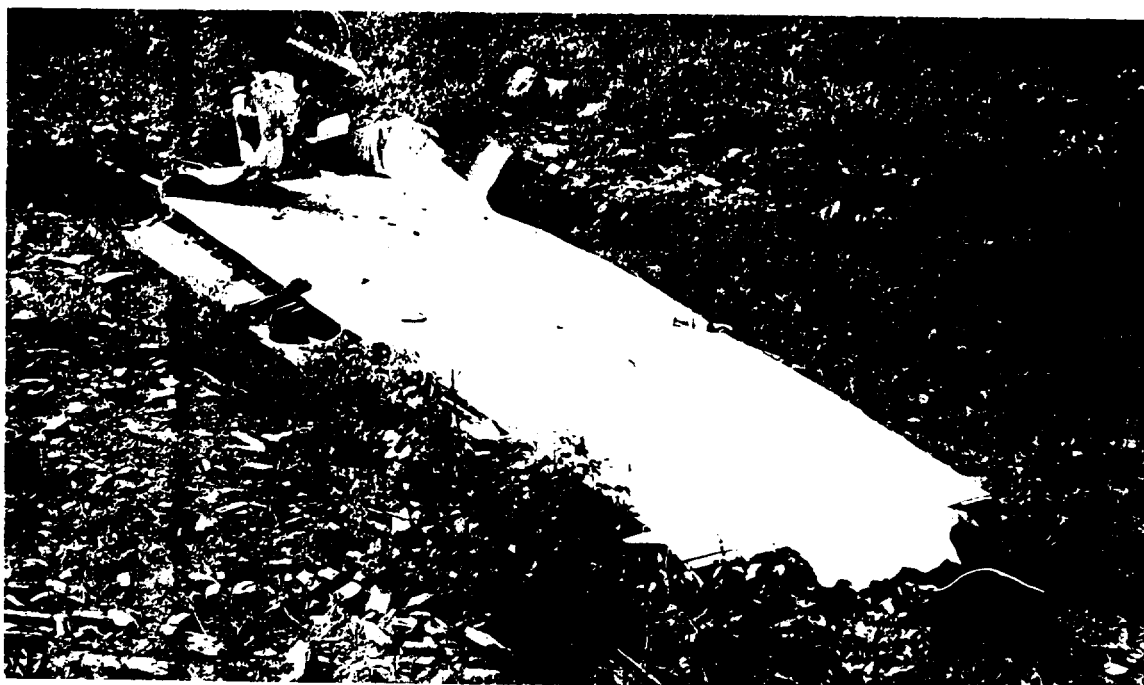
LEFT WING

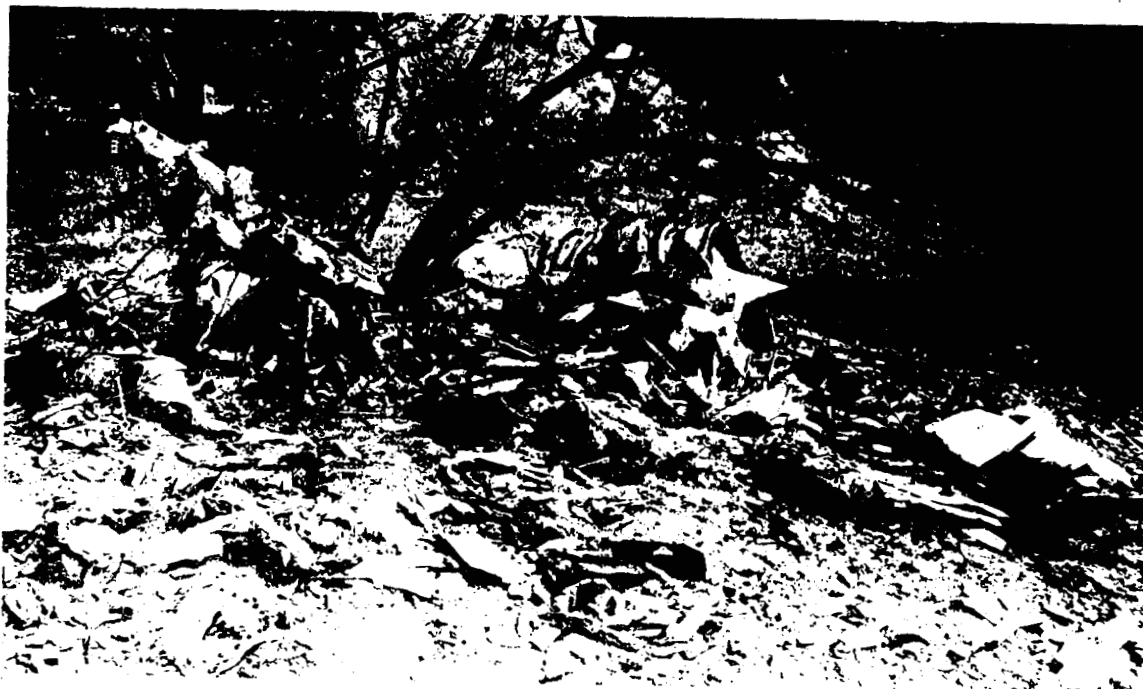
SEVERLY BURNT RIGHT ENGINE

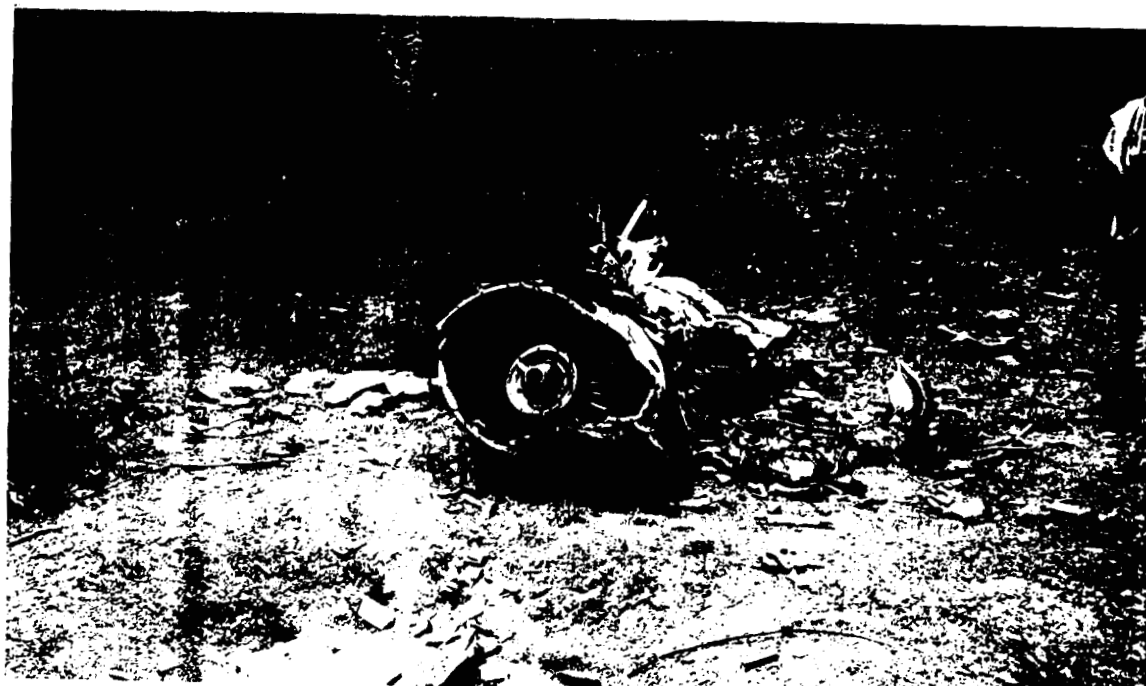
LEFT ENGINE
